Manhole Inspection Summary

Manhole # S05AA2036MH

Insp Date: **9/20/06 2:18 PM**

Location Address: **5942 CROSS COUNTRY BLVD** Cross Street: **PARKINGTON AVE**

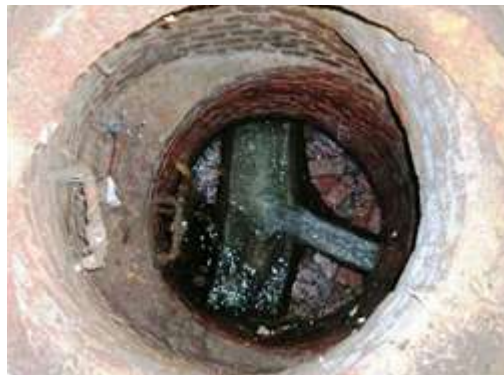
Top View

Bench ☒ Exists Material: **Brick** ☐ Parged ☒ **Debris** (not Condition related)
Condition: ☒ Sound ☐ Cracked ☐ Root Intrusion ☐ Deteriorated ☐ Leaks ☐ Debris

Steps Count: **7** Missing: **0** ☒ **Corroded**

Surcharge ☒ **Evidence Of Surcharge** Depth: **8** (ft.) ☐ Active Surcharge Present

Evidence of surcharge - Bench debris.
Corroded steps.

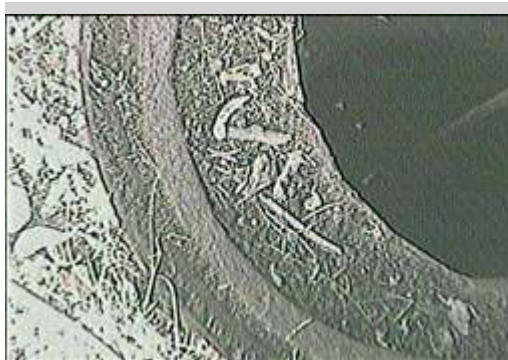
Defect

Frame Offset: **6** (in.) Condition: ☒ Sound ☐ Cracked ☐ Leaks

Frame offset.

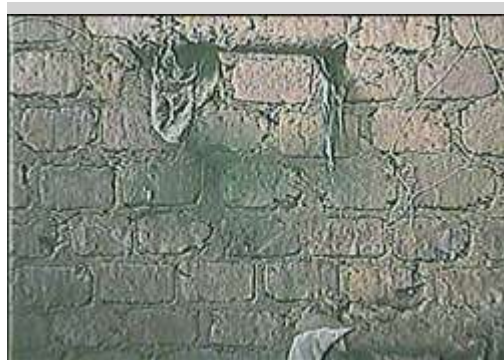
Defect

Chimney / Frame Adjustment ☒ Exists Material: **Brick** ☐ Parged Height: **19** (in.)
Condition: ☐ Sound ☐ Cracked ☒ **Root Intrusion** ☐ Loose Brick ☐ Deteriorated
Infiltration: ☐ None ☒ **Joint** ☐ Cracks ☒ **Mortar** ☒ **Roots** ☐ Wall

Evidence of surcharge. Adjustment root
intrusion and infiltration.

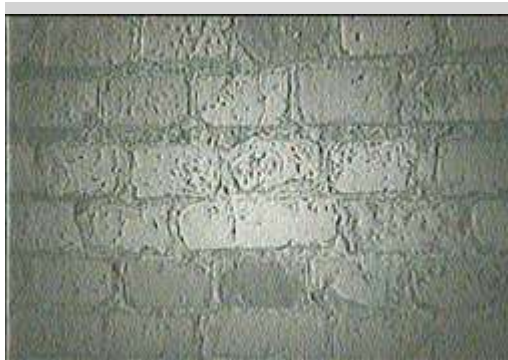
Defect

Corbel Material: **Brick** ☐ Parged Type: **Concentric/Eccentric**
Condition: ☒ Sound ☐ Cracked ☐ Root Intrusion ☐ Loose Brick ☐ Deteriorated
Infiltration: ☐ None ☐ Joint ☐ Cracks ☒ **Mortar** ☐ Roots ☒ **Wall**

Corbel/Barrel infiltration.

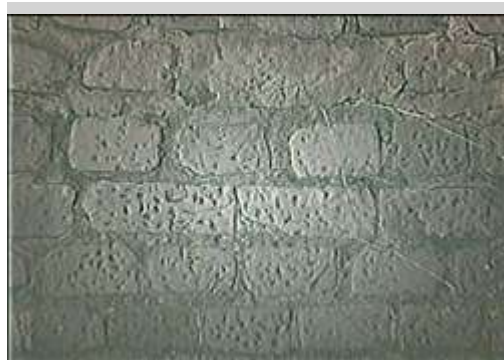
Defect

Barrel Material: **Brick** ☐ Parged
Shape: **Circular** Diameter: **48** (in.) Length: (in.)
Condition: ☐ Sound ☐ Cracked ☒ **Root Intrusion** ☐ Loose Brick ☐ Deteriorated
Infiltration: ☐ None ☐ Joint ☐ Cracks ☒ **Mortar** ☒ **Roots** ☒ **Wall**

Corbel/Barrel root intrusion and
infiltration.

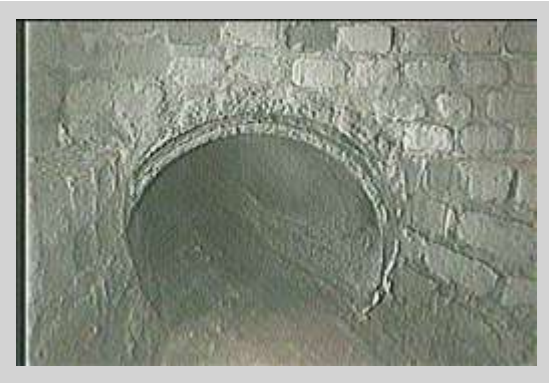
21 in. Circular Gravity Sewer Pipe Out @ 12 O'Clock

Infiltration: **Evidence** Pipe Seal Cond: **Unknown**

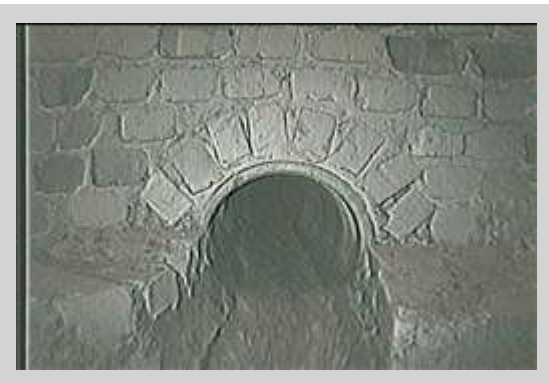
10 in. Circular Gravity Sewer Pipe In @ 4 O'Clock

Infiltration: **Evidence** Pipe Seal Cond: **Unknown**

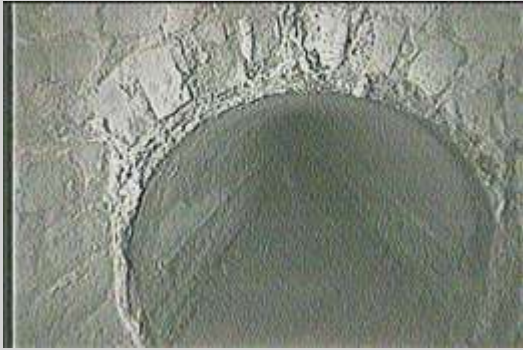
Pipe In @ 6 O'Clock

Infiltration: **Evidence** Pipe Seal Cond: **Cracked**
